Maryland Inventory of Historic Properties Form

Inventory No. HO-646

historic Burgess-Sullivan House
other Mary Selby Burgess House

street and number 3075 Maryland Route 32 not for publication
city, town West Friendship X vicinity
county Howard

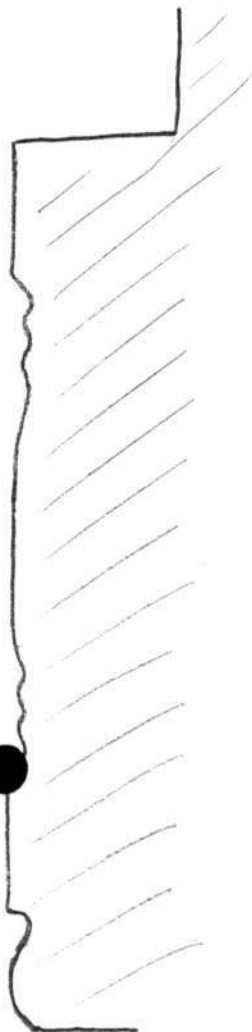
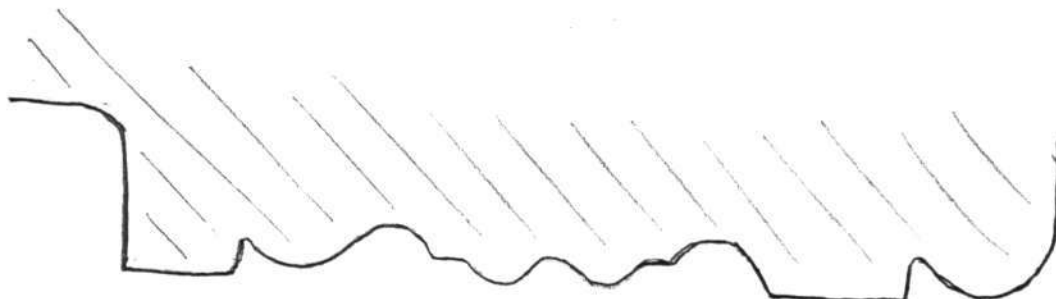
1/1 3075 Rte. 32 HO-646
Moulding Profiles

SW Addition
Window
Architrave

NE. Rm. Architrave

architrave has two beads in the center with a cavetto to the inner side, a quirked ogee to the outer side, and a beaded interior edge. The front door on the northwest has 15 lights, butt hinges with ball finials, and a mortise lock with a metal knob that is painted. There is a fireplace on the southwest elevation that has a tile hearth, a brick surround, and a metal firebox. The hearth is raised several inches. The fireplace has an architrave surround that has wide, flat ogee backband and a small ogee on the inner edge. There is V-groove vertical board walling on the fireplace, and a simple wood shelf on two brackets. There are metal grilles on the wall associated with the fireplace, and a built-in cupboard to the northwest that has two doors on faux HL hinges below three adjustable shelves. There is an earlier existing fireplace behind the walls of the present fireplace, with the walls having been built out with dimensional 2 by 4s. The sidewalls of the old fireplace have lath and plaster on studs set against the brick wall. The baseboard matches that in the southwest room, and there appears that there must have been a mantel on the northwest room side, but this had been removed when the fireplace was rebuilt.

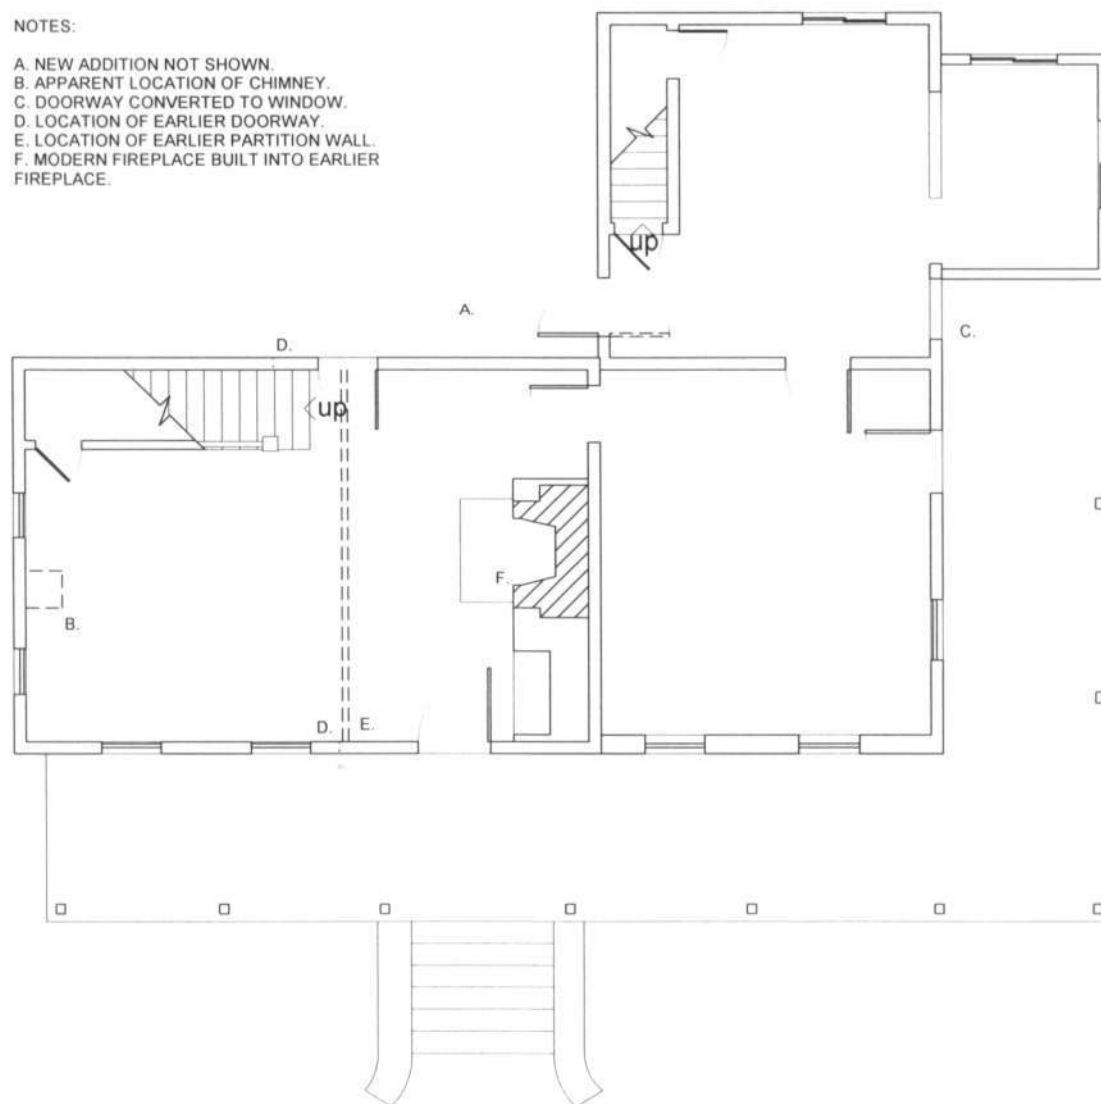
FIRST FLOOR PLAN - MEASURED AND DRAWN BY KEN SHORT - APRIL 2006

- A. NEW ADDITION NOT SHOWN.
- B. APPARENT LOCATION OF CHIMNEY.
- C. DOORWAY CONVERTED TO WINDOW.
- D. LOCATION OF EARLIER DOORWAY.
- E. LOCATION OF EARLIER PARTITION WALL.
- F. MODERN FIREPLACE BUILT INTO EARLIER FIREPLACE.

The house has a hall-parlor plan with a one-room ell on the southeast, set to the east. The northeast room has carpet on the floor. The baseboard has a quirked ogee and bevel on top. The walls are plaster, with ceiling tile and wood crown moulding. The

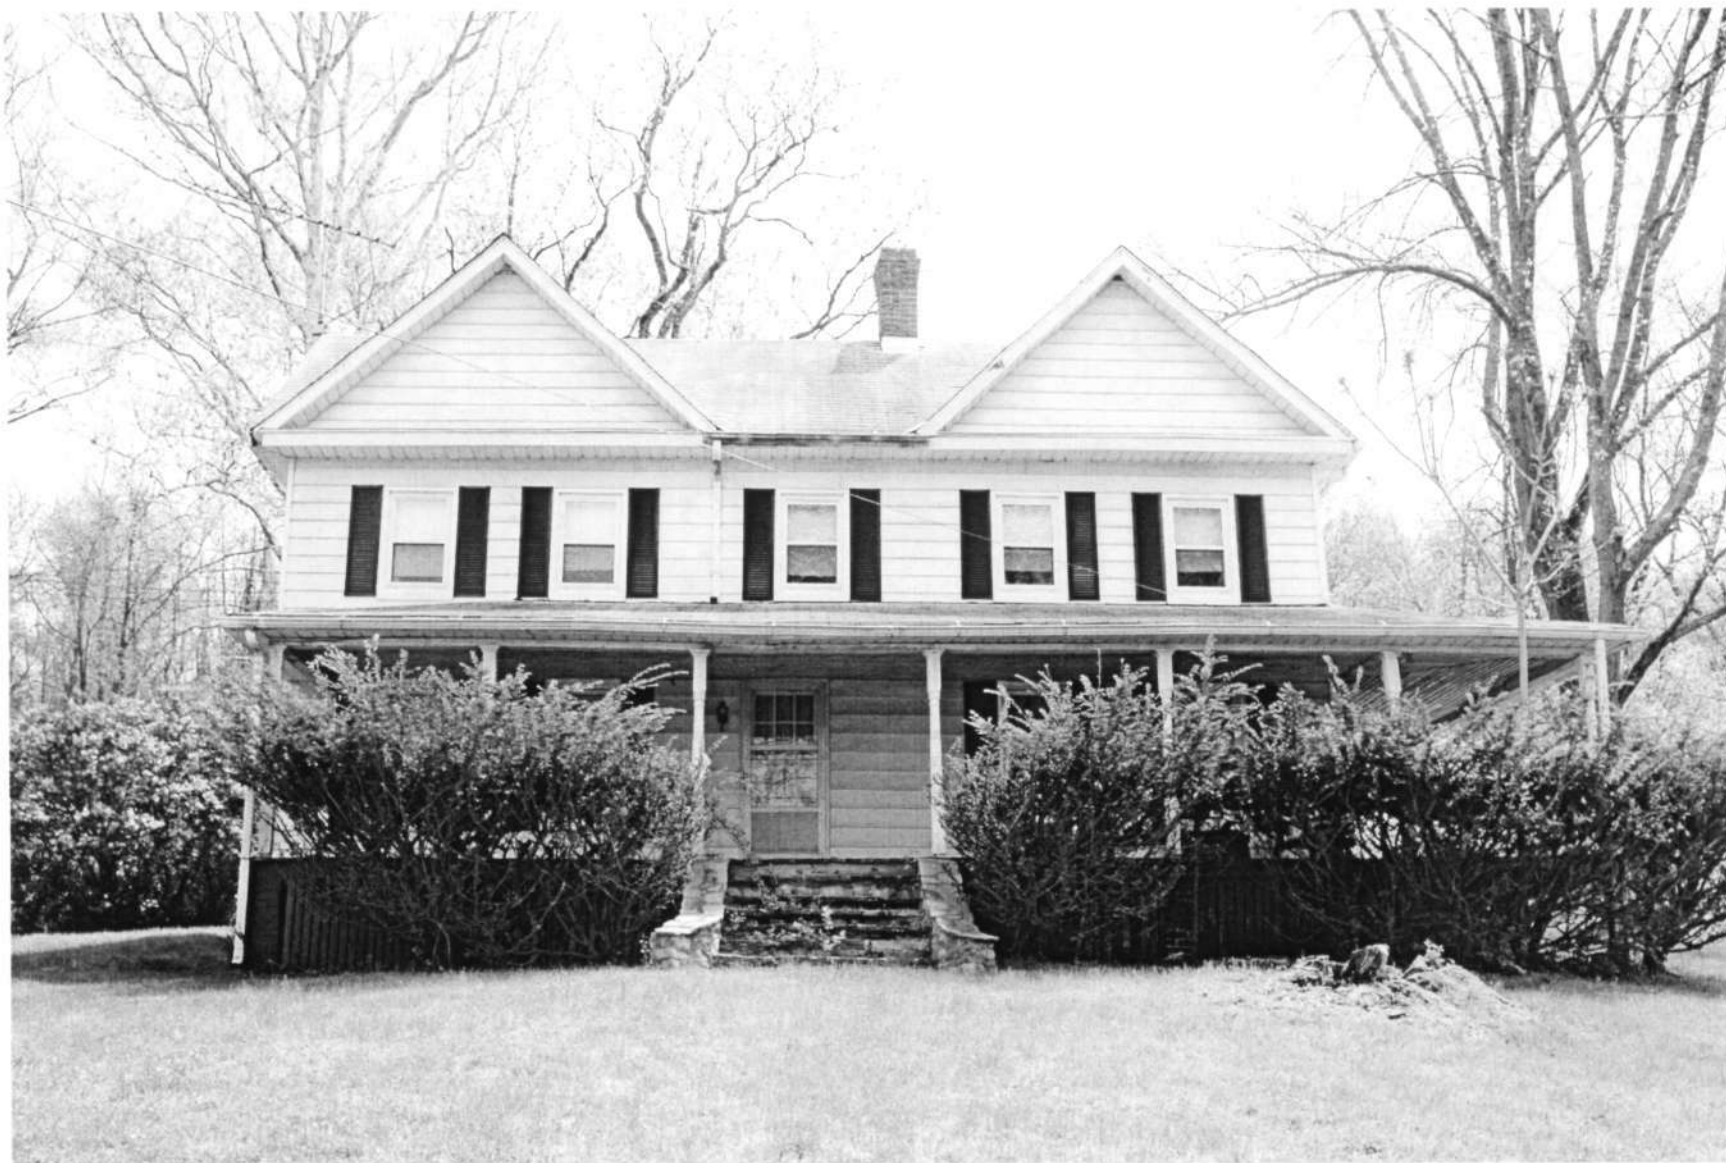
HO-0646 Burgess-Sullivan House 3075 MD Route 32, House-northwest elevation
Ken Short, April 2006 1/10

The main house is a 2-1/2 story, five-bay by two-bay structure with a rubble stone foundation, aluminum siding, and a gable roof with asphalt shingles and a northeast-southwest ridge. There is an ell on the rear of the building that is two stories and two bays by two bays. It has a gable roof that runs northwest-southeast. There is an interior brick chimney set southwest of center. The northwest elevation has a raised porch with lattice, and six stone steps in the center with stone cheek walls that flare at the bottom. The first story has a center doorway with a 15-light door. There are two new one-over-one double-hung sash with fake shutters on either side of the doorway and all of the sash in the house are new one-over-ones. The porch has a new pressure-treated deck and seven turned posts. The soffit has boards that are beaded on both edges with gaps between each pair of boards. The porch wraps around on the southwest, with a hip roof at this corner. The second story has five one-over-one sash. There is an overhanging eave with a box cornice that is carried around all sides. The northwest elevation has two gabled wall dormers, each dormer set over the two end bays, with no openings now.

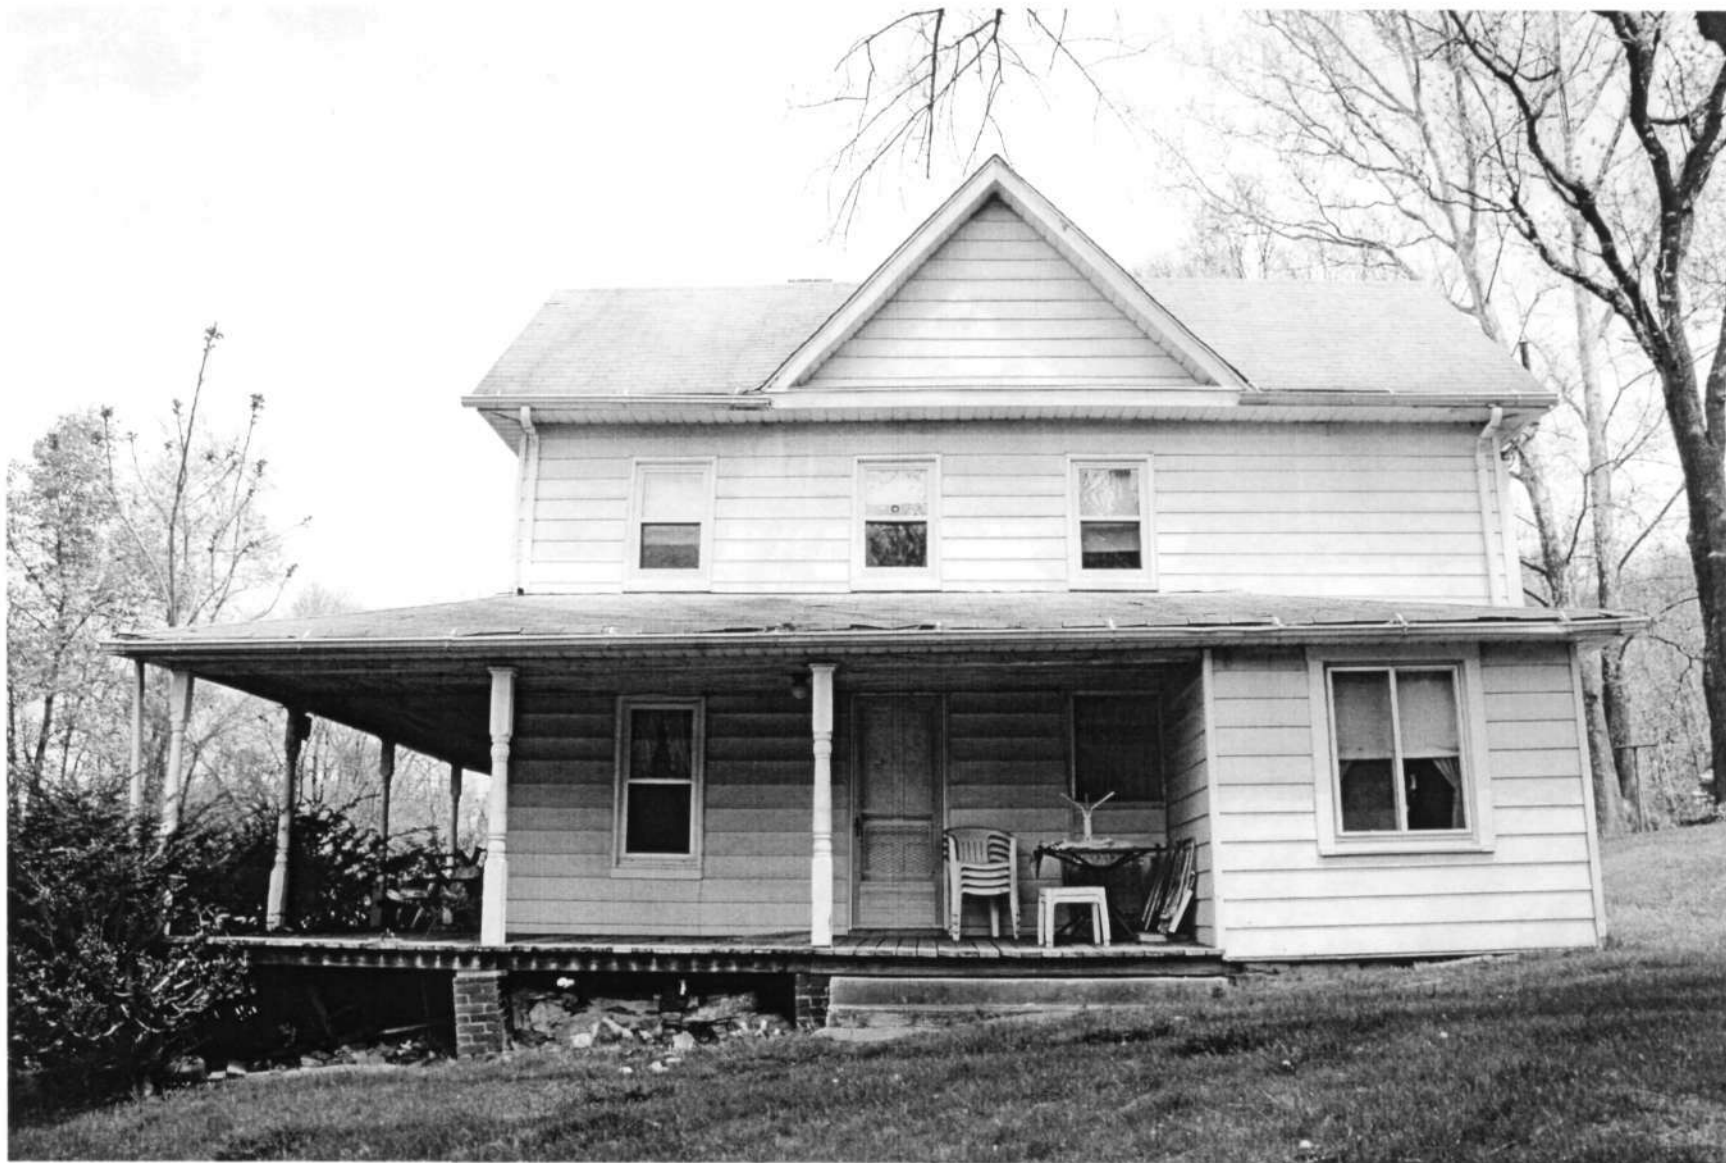
HO-0646 Burgess-Sullivan House 3075 MD Route 32, House-southwest elevation
Ken Short, April 2006 2/10

The southwest elevation has the porch set on stone piers, with a rubble stone cellar bulkhead under the porch, in the west bay. The first story has a one-over-one sash in the west bay. The west-center bay has a four-panel door that has sunken fields and ogee panel moulds. The south-center bay is a closed-off doorway that now contains a new window. The south bay has had the porch enclosed, with a two-light sliding aluminum sash. Including the west corner, the porch has three turned posts. The second story has three one-over-one sash with no opening in the south bay. There is a gabled wall dormer centered on this elevation. The southeast elevation has an identical window to the southwest elevation in the end of the porch. The first story of the ell has a small two-light sliding sash in the south bay and the second story of the ell has a one-over-one sash in the south bay. The cornice is carried around on this elevation, too. There is a shed-roof addition in the reentrant angle, with a one-over-one sash on the southeast and a door on the northeast. A shed-roof porch continues to the northeast of the addition, with one turned post, and there is a doorway under this porch with a flush door. The porch is constructed of all new dimensional lumber with wire nails. The second story has a one-over-one sash in the center and east bays, and there is a CMU chimney just east of center. The northeast elevation of the ell has no opening on the second story. The northeast elevation of the house has two one-over-one sash on the first story and no openings on the second story and gable end. The siding under the new addition is German siding on both the ell and the block.

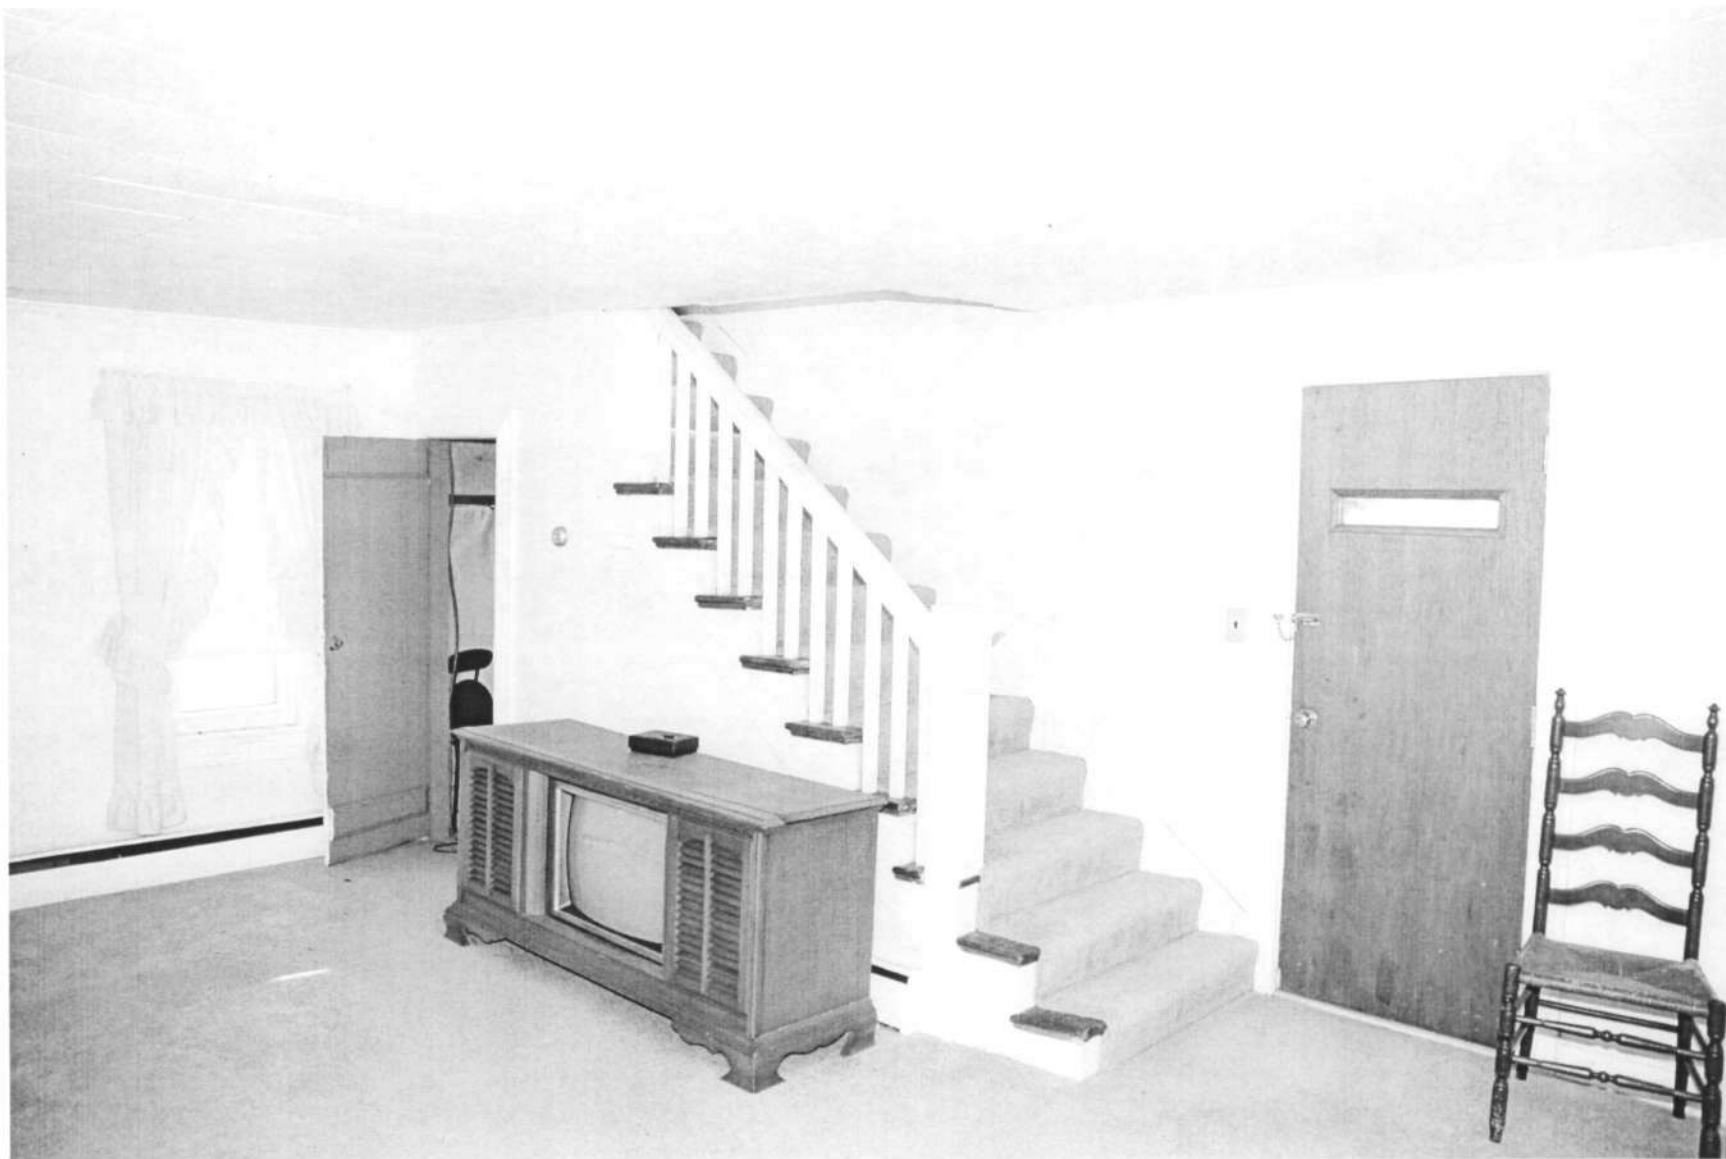
HO-0646 Burgess-Sullivan House 3075 MD Route 32, House-northeast room, view east
Ken Short, April 2006 5/10

In the northeast room, the north corner post is 4 inches by 6 inches and appears to have been cut with a sash saw though there is possibly a very narrow curve to the saw marks. There is no corner brace on the northwest wall north corner post. The wall has balloon framing with the 2 by 4 studs going straight up through the second story, and there is no fire block. The lath is circular-sawn and is fastened with cut nails. The northwest wall under the center bay windowsill has wire lath nails, and there was apparently a door located here, set to the west of where the window is presently by about 1 foot. The southeast wall has the same arrangement suggesting that there was a door on the back, across from the front door. This door was about 18 inches east of the existing door, in line with the current stair newel post. The northwest wall original plaster was plastered over and patched just west of where the door was. There is a ghost here of a stud wall that ran northwest-southeast and divided the northwest room into two. The plaster to the west was painted blue. The closet beneath the stairway has lath that is fastened with wire nails.

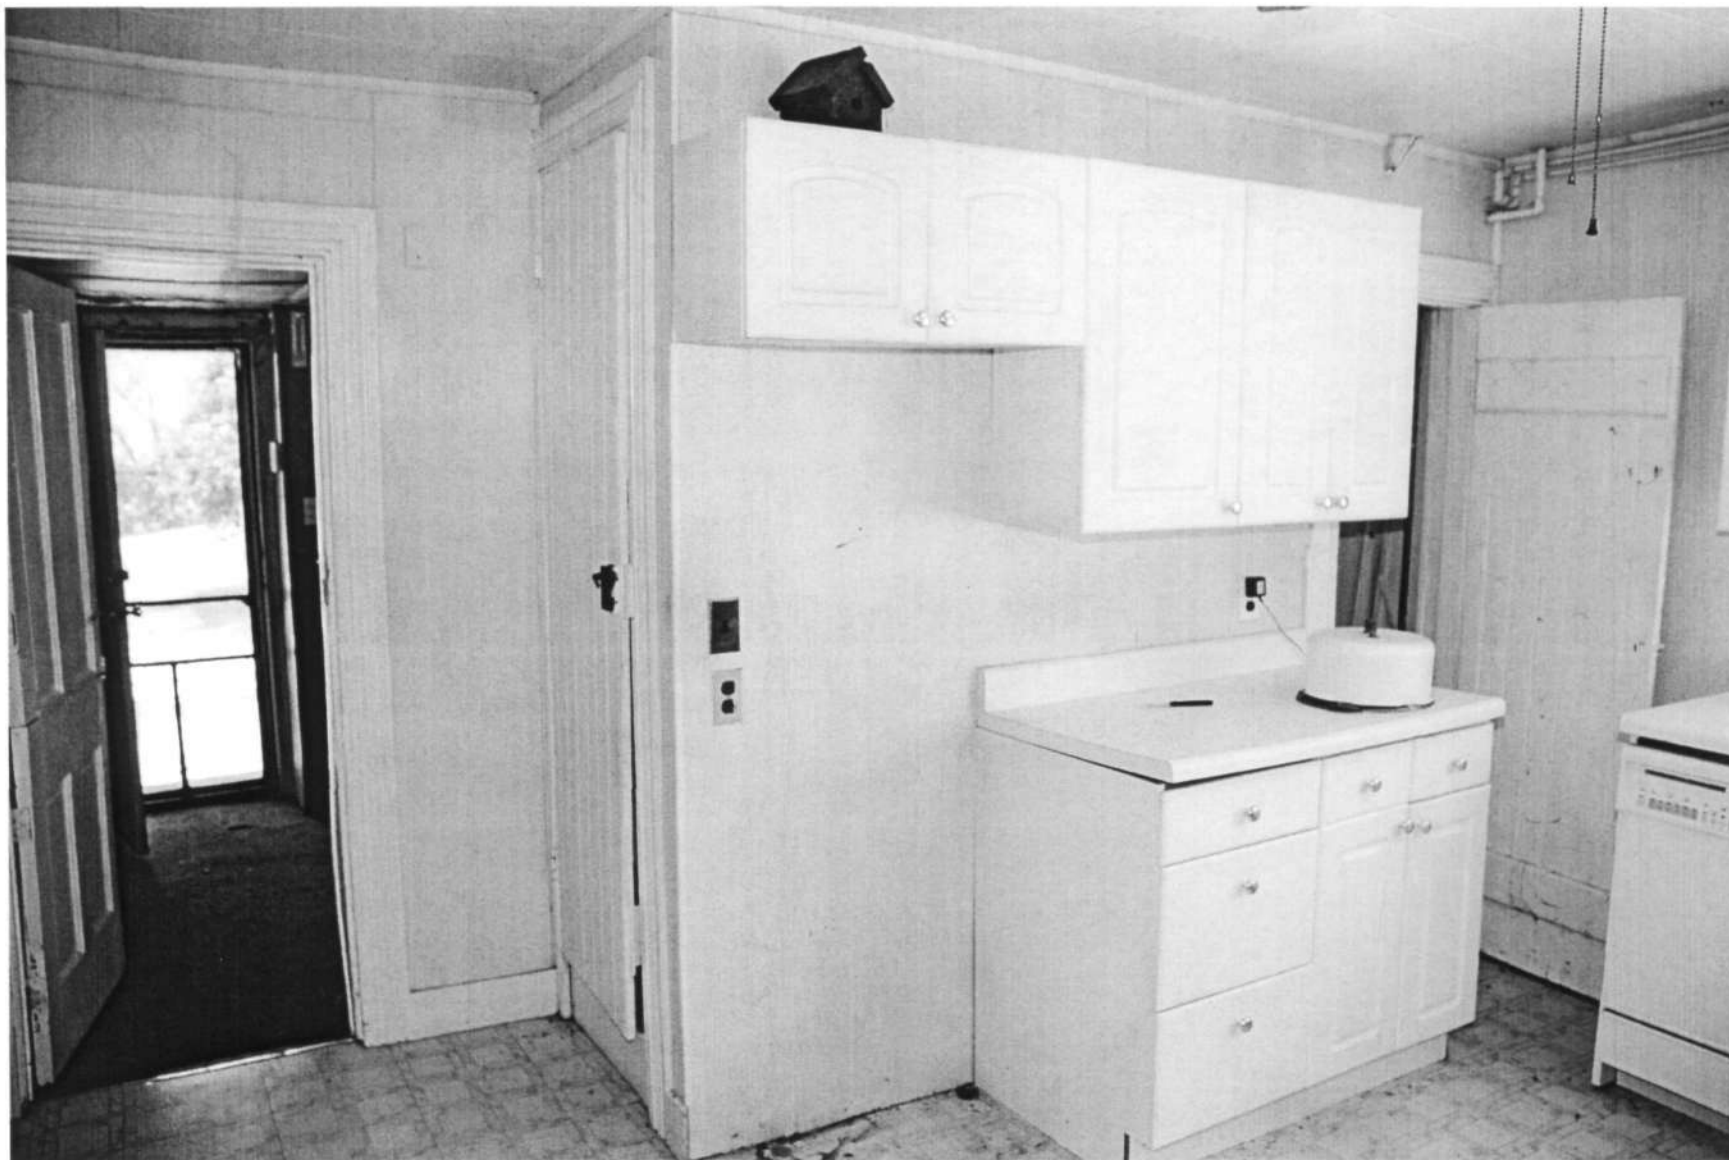
HO-0646 Burgess-Sullivan House 3075 MD Route 32, House-ell room, view east
Ken Short, April 2006 7/10

The ell room is a modern kitchen with linoleum, paneling on the walls, and ceiling tiles. The architrave is typical of the rest of the house, and there is an enclosed stair on the northeast that ascends up to the southeast. There is a beaded-edge vertical board door

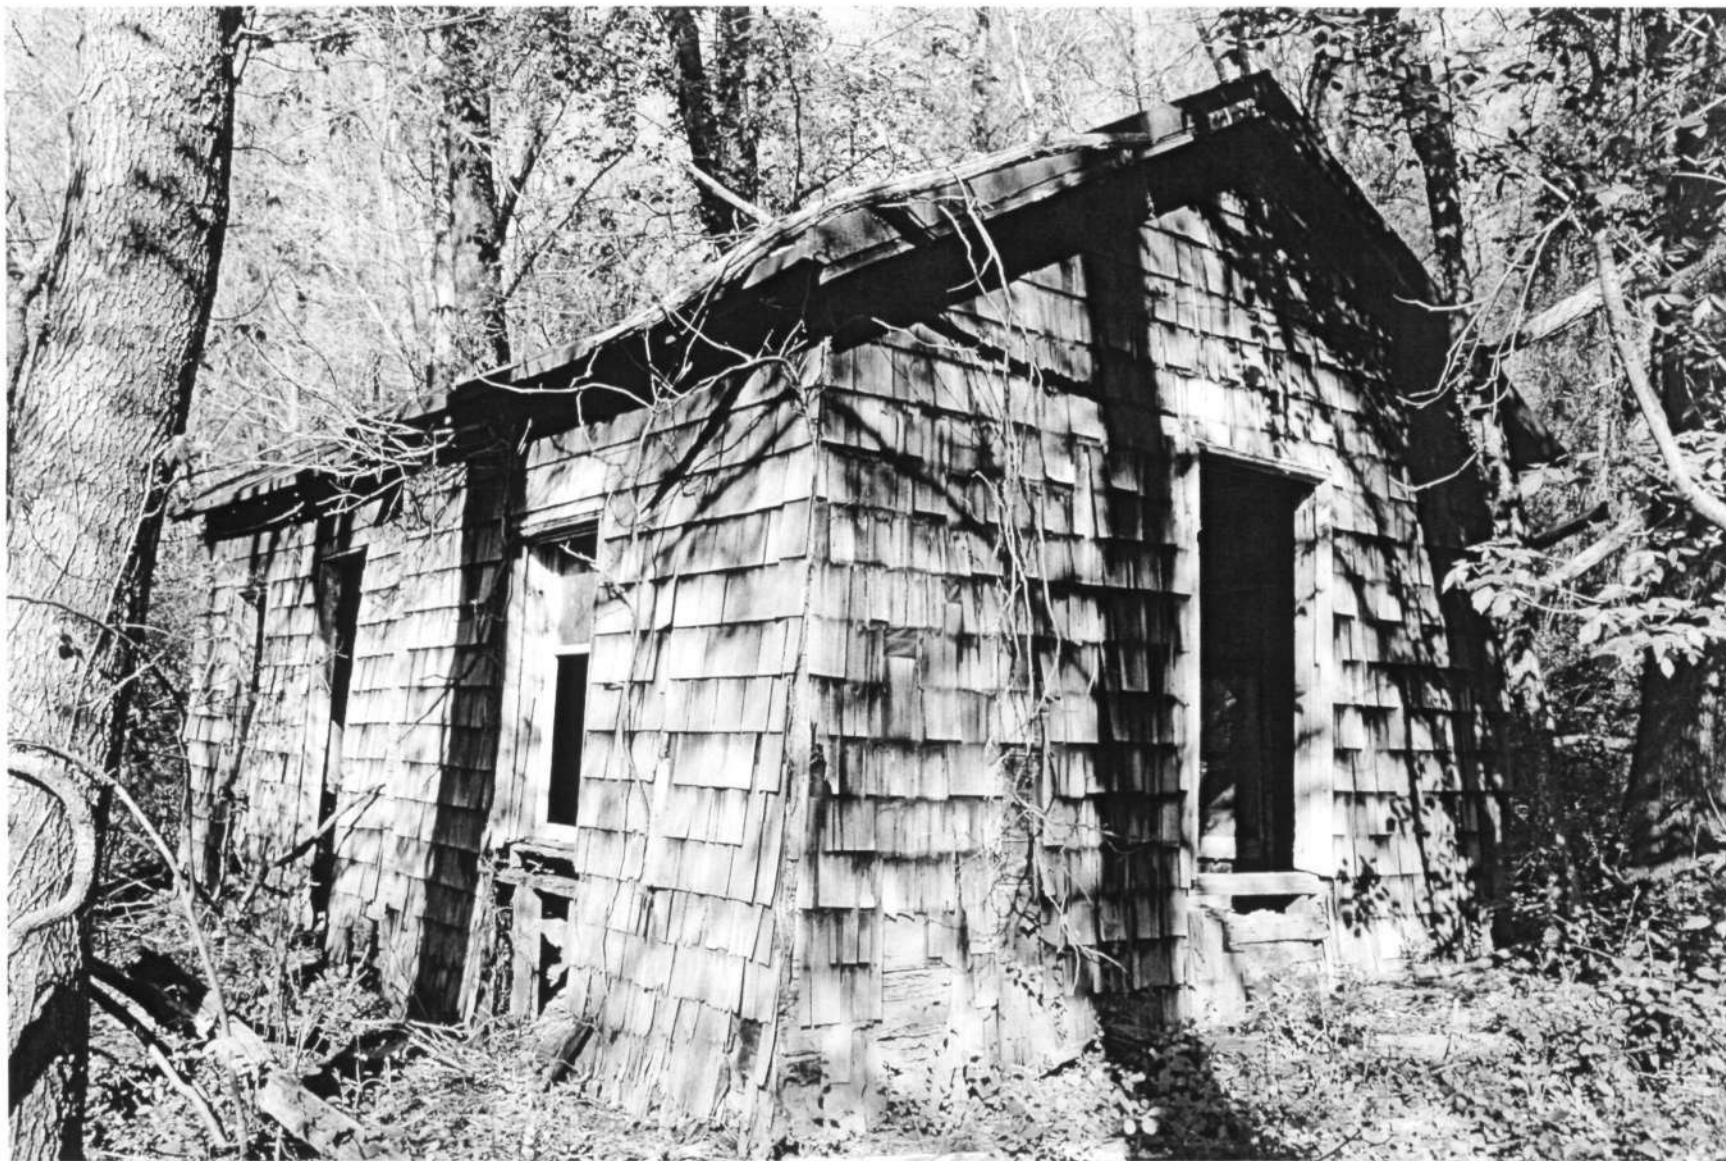
HO-0646 Burgess-Sullivan House 3075 MD Route 32, Tenant House-northwest & southwest elevations
Ken Short, April 2006 8/10

There is a tenant house located about 120 feet east of the house, and is hidden amongst dense overgrowth. It is a one-story, three-bay by one-bay frame structure with no visible foundation. The sill is rotted and the building is collapsing. The frame is covered with wood shingles fastened with wire nails, and there is a gable roof with standing seam metal and a northeast-southwest ridge. The northwest elevation has a doorway in the center bay, but the door is gone. The north bay has a window opening with the jambs nailed with cut nails. There is a six-light sash remaining here, part of what was a six-over-six sash, and it has mortised and

tenoned and pinned corners. The opening has a beaded-interior-edge frame. The west bay has a large two-light sash stuck into the opening. The rafter ends are exposed. The northeast elevation has a window opening that has been closed over with shingles. The southwest elevation has a window opening and the jambs had parting beads. There are holes for sash cord pulleys, which are missing. The southeast elevation has a six-panel door in the south bay, but the two center panels were removed and two-light sash nailed over this opening. The door has sunken fields and quirked-ogee-and-bead panel moulds. There are no other openings on this elevation.

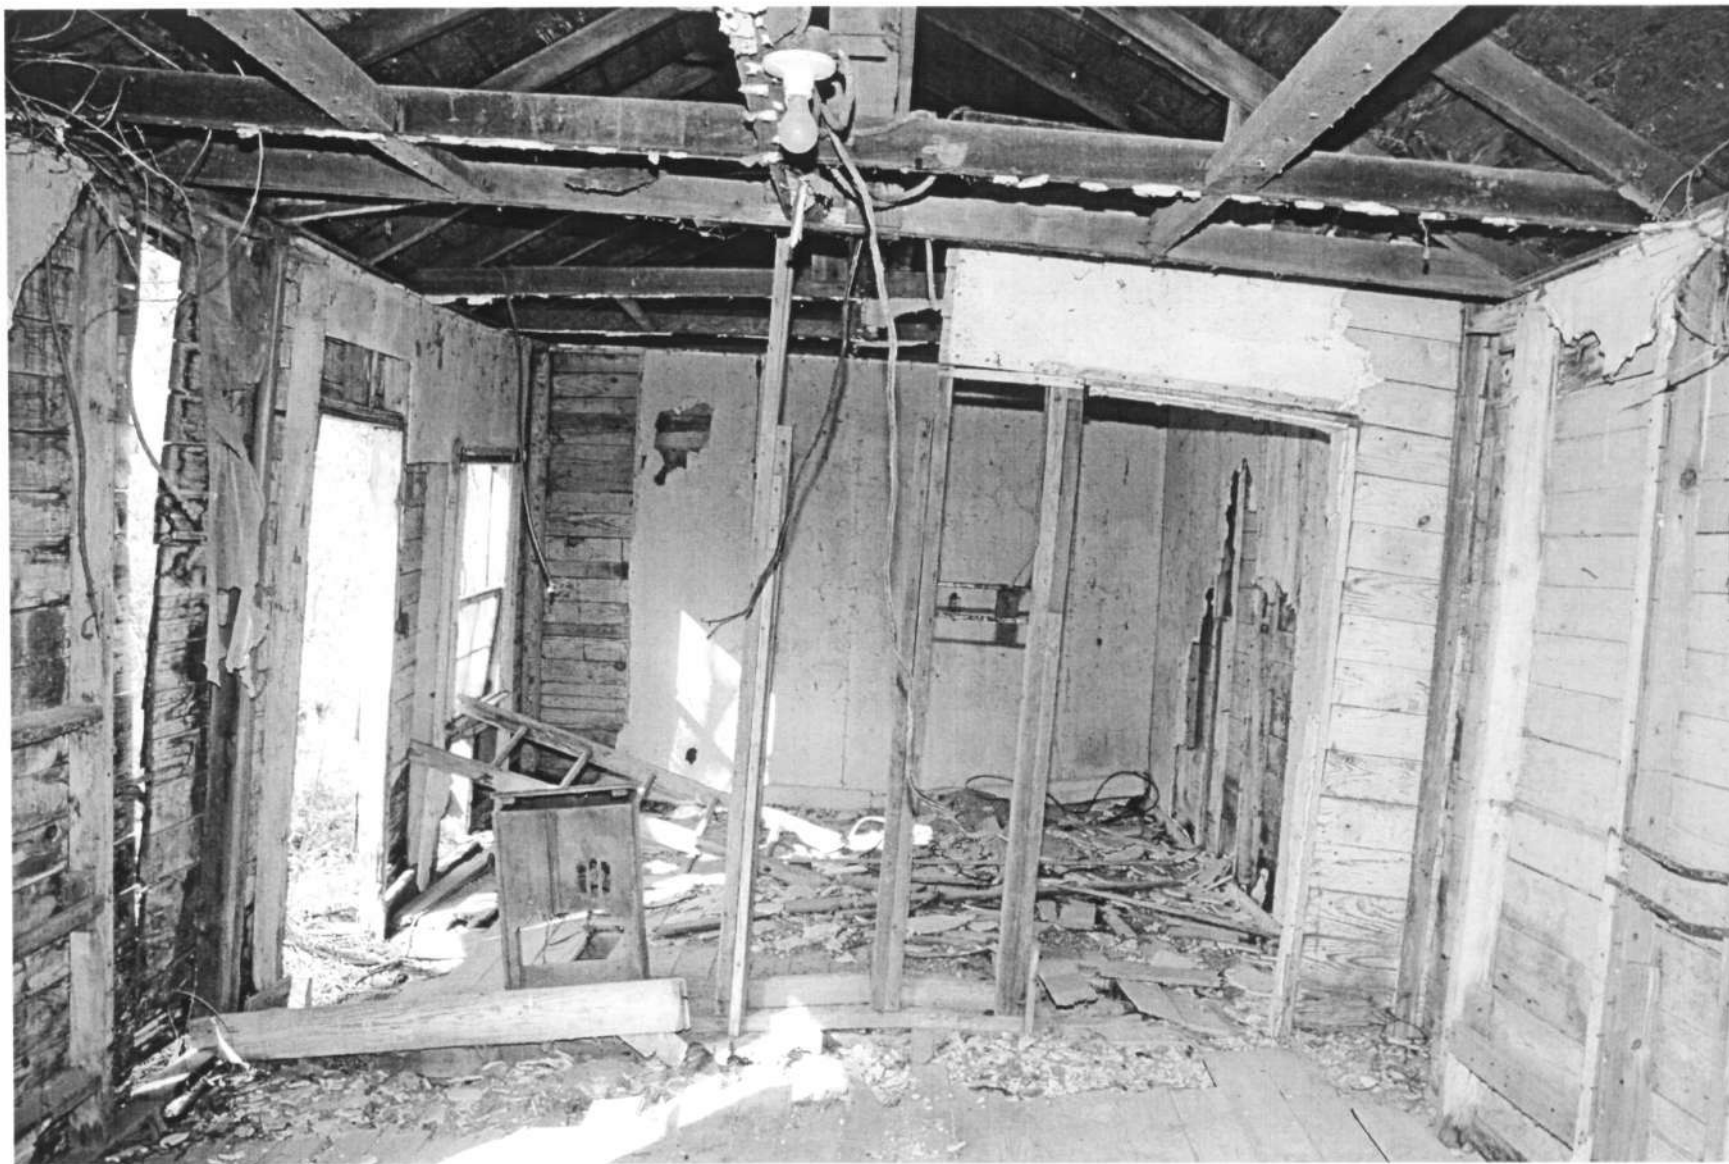
HO-0646 Burgess-Sullivan House 3075 MD Route 32, Tenant House-interior, view northeast
Ken Short, April 2006 9/10

The interior of the tenant house has a hall-parlor plan, and is of 2 by 4 construction with 4 by 4 corner posts, 1 by 4 plates and 2 by 4 rafters with a ridgepole. The rafters support board sheathing. There was drywall on the ceiling at one time fastened with wire nails. They were exposed and the studs and sheathing painted, and this was later covered with drywall. There is a partition wall southwest of the northwest doorway, and it consists of studs with horizontal painted boards. The flooring is 5-inch tongue and groove pine that runs northeast-southwest. The joists are 3-1/2 inches square, run northwest-southeast, and probably were not originally set on the ground as they are now, due to deterioration. There is a patched hole in the center of the roof suggesting a chimney was located here between the two rooms.

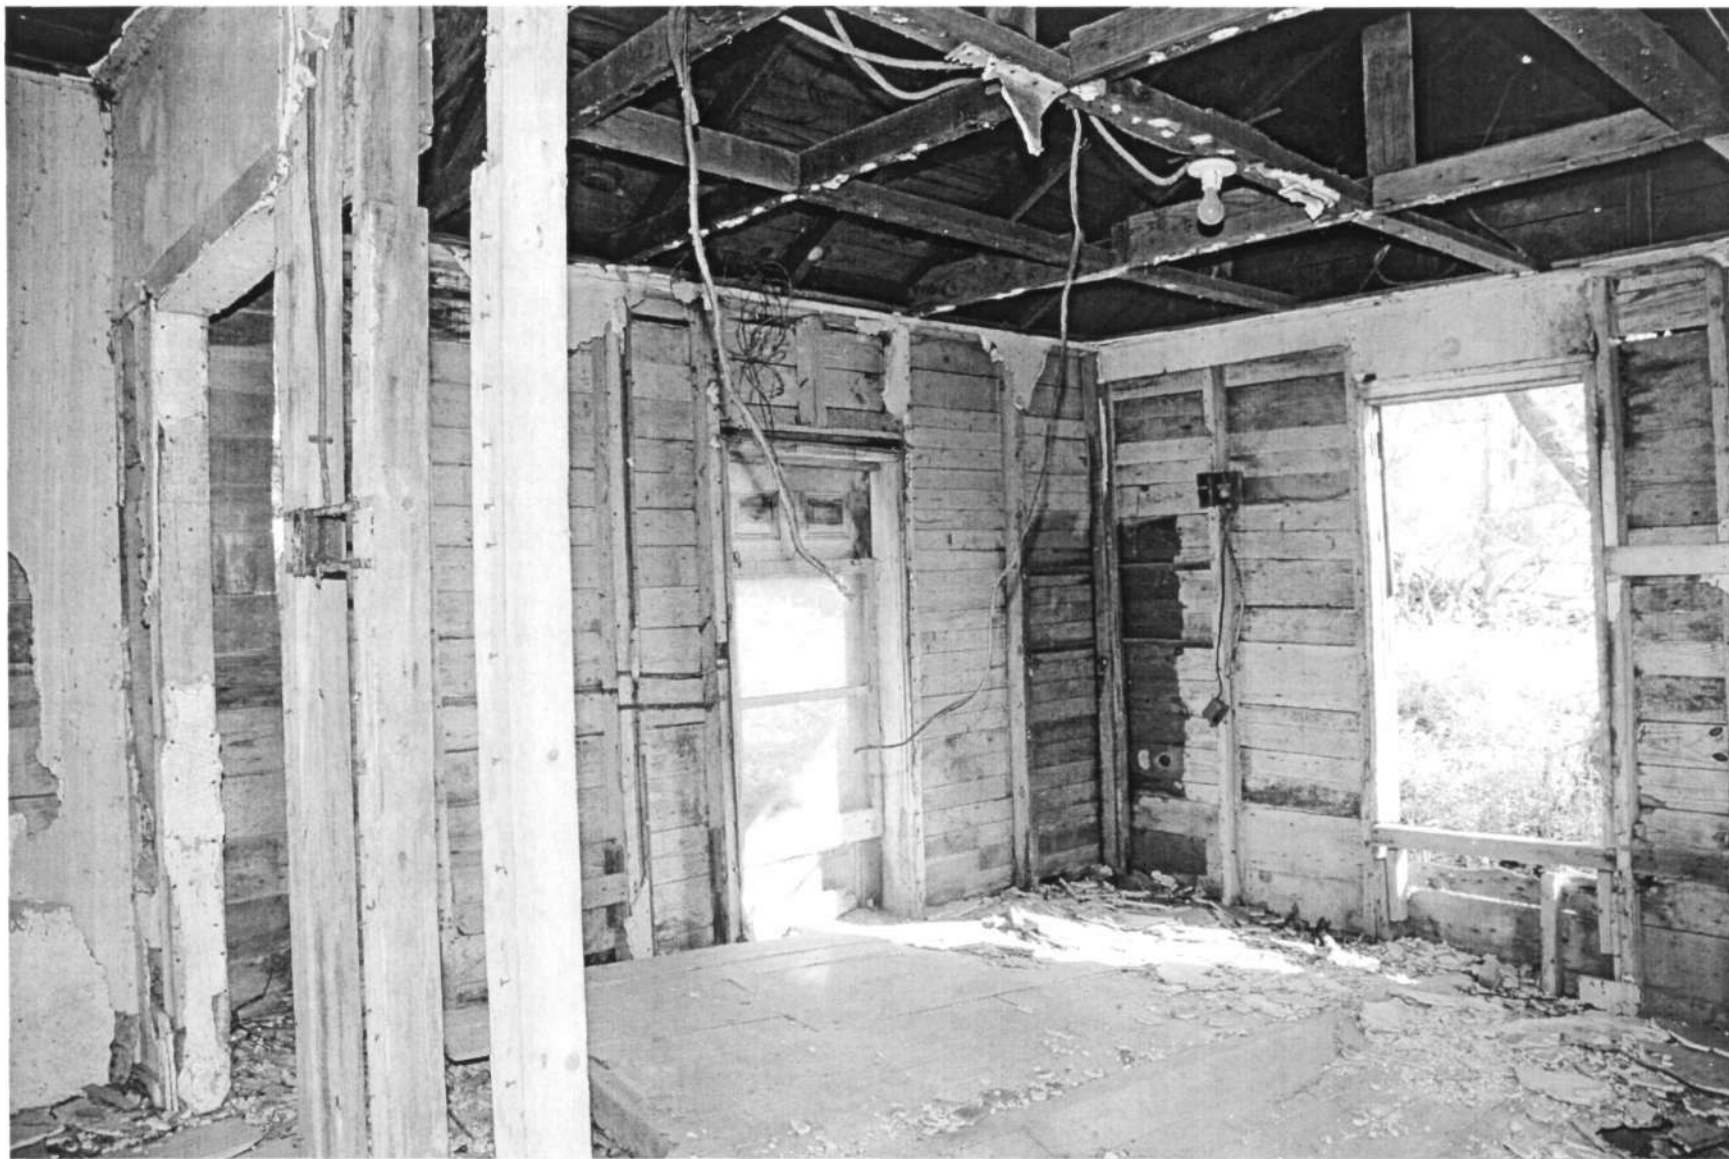
HO-0646 Burgess-Sullivan House 3075 MD Route 32, Tenant House-interior, view south
Ken Short, April 2006 10/10
